South Africa ecoSolv Water Device Test

Images presented below depict the cleaning of sprinkler heads at VCG Trade in Malmsbury. Here, a 2" (50 mm) ecoSolv Water-Device was installed on the 20th of November 2020. Images below were taken exactly one week later on the 27th of November 2020.

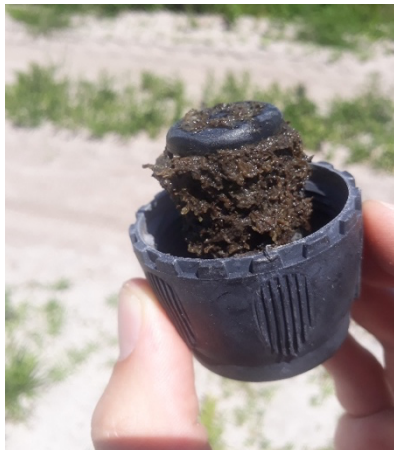
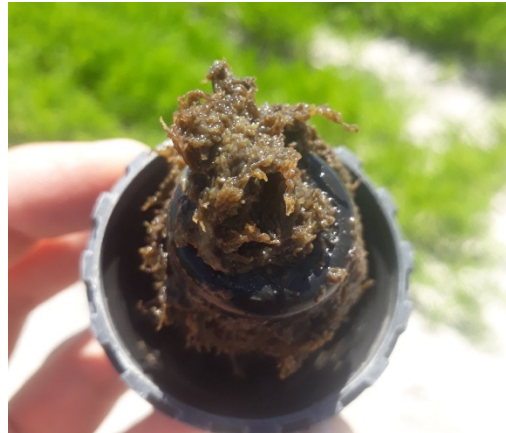
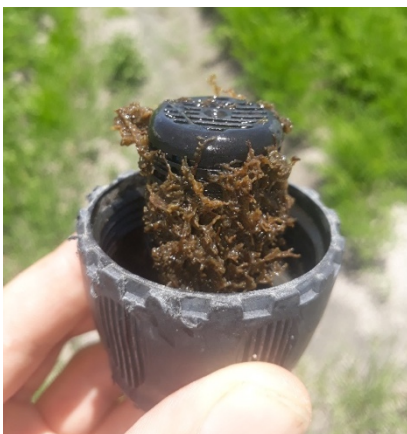
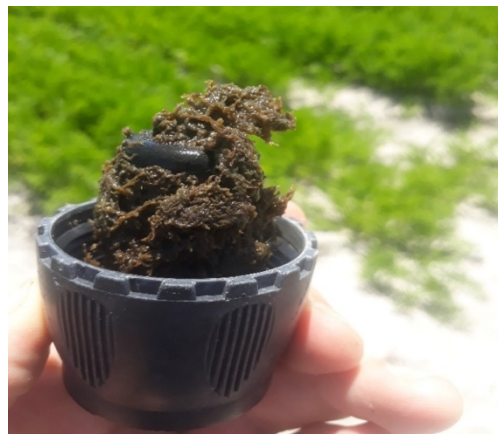
Untreated Blocks

The opposite is true for the alongside (untreated block). **58.3% of the sprinkler heads are severely blocked**, while **25% were blocked, but still functional**. The remaining **16.67% were functional**

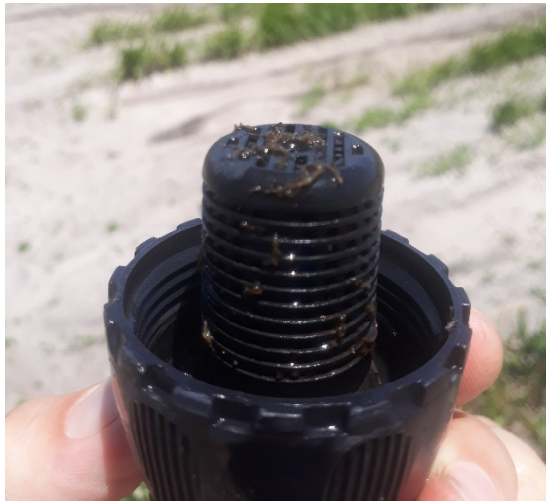
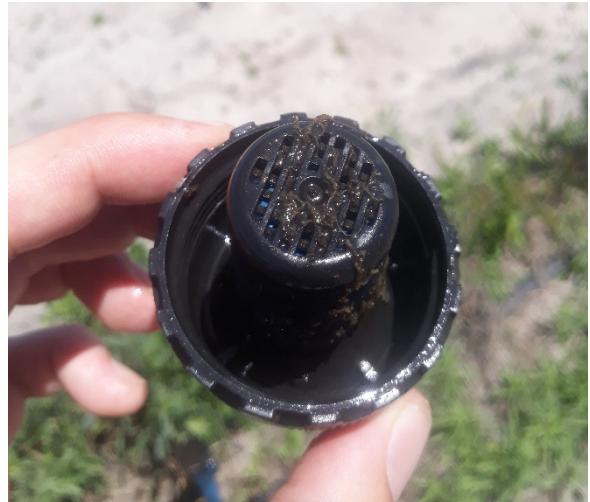
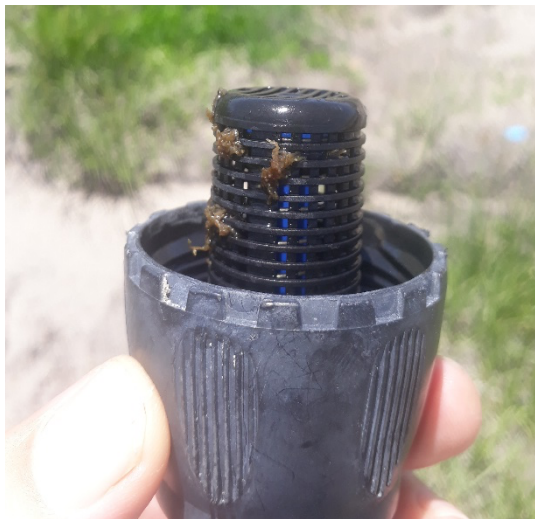
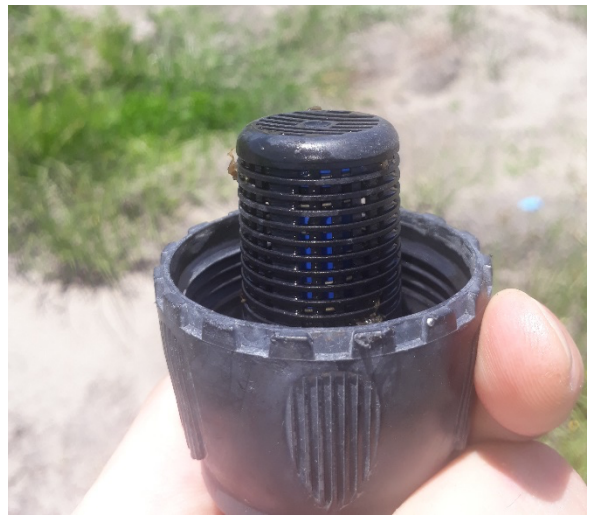
ecoSolv Water Treated Blocks

The ecoSolv Water-Device appears to be creating a release of organic material within the treated lines at VCG Malmsbury. The extent is approximately **62.5% completely clean sprinkler heads**, while only **12.5% of the lines remain slightly blocked**, and **25% are performing at a high level of functionality**.

After installation of the Water-Device on the 20th, a flush of the treated lines was conducted, as instructed. This flush of the irrigations lines is necessary for removal of unwanted material found as a build-up on the inner-lining of the mains and end lines of the system.
